Manhole Inspection Summary

Manhole # S41II_032MH

Insp Date: **10/22/07 2:34 PM**

Location Address: **1425 FEDERAL ST**

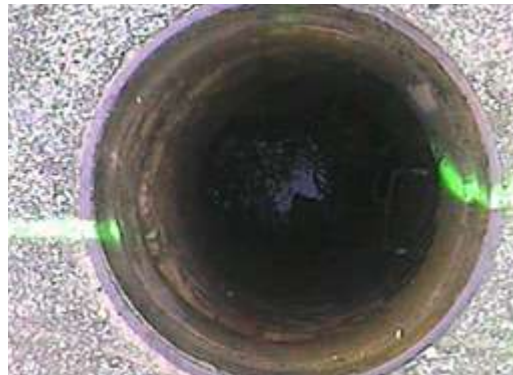
Defect 1

Count: **6** Missing: **1** ☒ **Corroded**

STEPS CORRODED

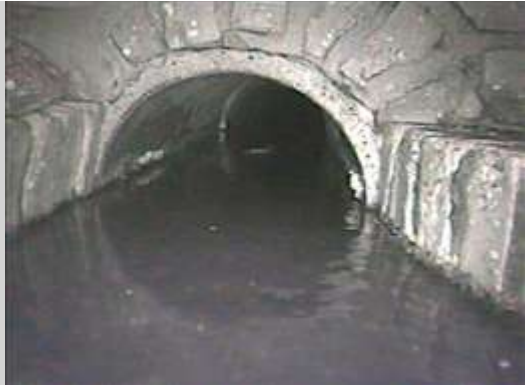
12 O'Clock Outflow

10 in. Circular Gravity Sewer
Pipe Out @ 12 O'Clock

Pipe Height: **7.2** (in.) Rod and Bar
Pipe Material: **Clay** ☐ Pipe Lined
Invert Depth: **9.83** (ft.) Flow Characteristics: **Slow**
Deposits: ☐ None ☐ Mud ☐ Sludge ☒ **Debris** ☐ Grease
Silt Depth: **2** (in.) Deposits Extent: **Light**
Infiltration: **None** Pipe Seal Cond: **Sound**

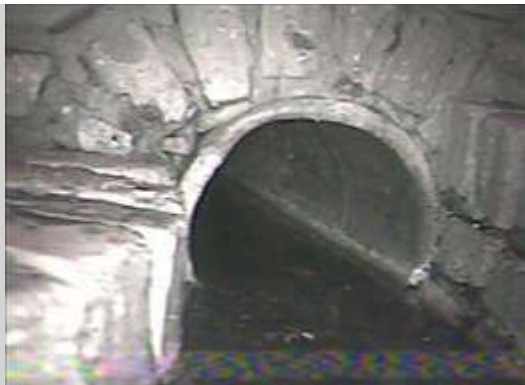
3 O'Clock Inflow

10 in. Circular Gravity Sewer
Pipe In @ 3 O'Clock

Pipe Height: (in.) Direct
Pipe Material: **Clay** ☐ Pipe Lined
Invert Depth: **9.76** (ft.) Flow Characteristics: **Slow**
Deposits: ☐ None ☐ Mud ☐ Sludge ☒ **Debris** ☐ Grease
Silt Depth: **2** (in.) Deposits Extent: **Light**
Infiltration: **None** Pipe Seal Cond: **Sound**

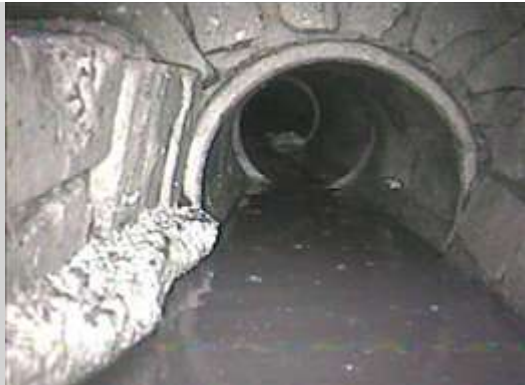
6 O'Clock Inflow

Deposits: ☐ None ☐ Mud ☐ Sludge ☒ **Debris** ☐ Grease

Silt Depth: **2** (in.) Deposits Extent: **Light**

Infiltration: **Evidence** Pipe Seal Cond: **Sound**

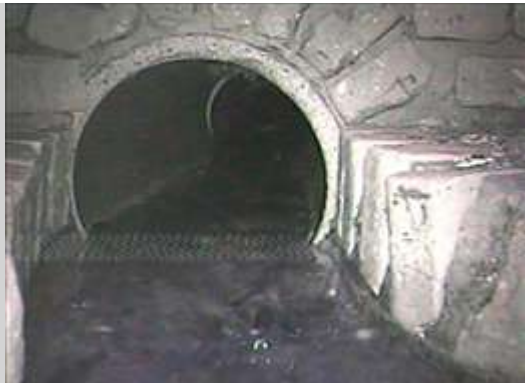
9 O'Clock Inflow

Deposits: ☐ None ☐ Mud ☐ Sludge ☒ **Debris** ☐ Grease

Silt Depth: **2** (in.) Deposits Extent: **Light**

Infiltration: **None** Pipe Seal Cond: **Sound**
